Tweed Courthouse: New Approach to Life-Safety Management in a Landmark Public Building

When restoring monumental public buildings for new uses, a performance-based approach to building-code compliance can allow the architectural integrity and historic features of a building to be preserved without compromising life safety.

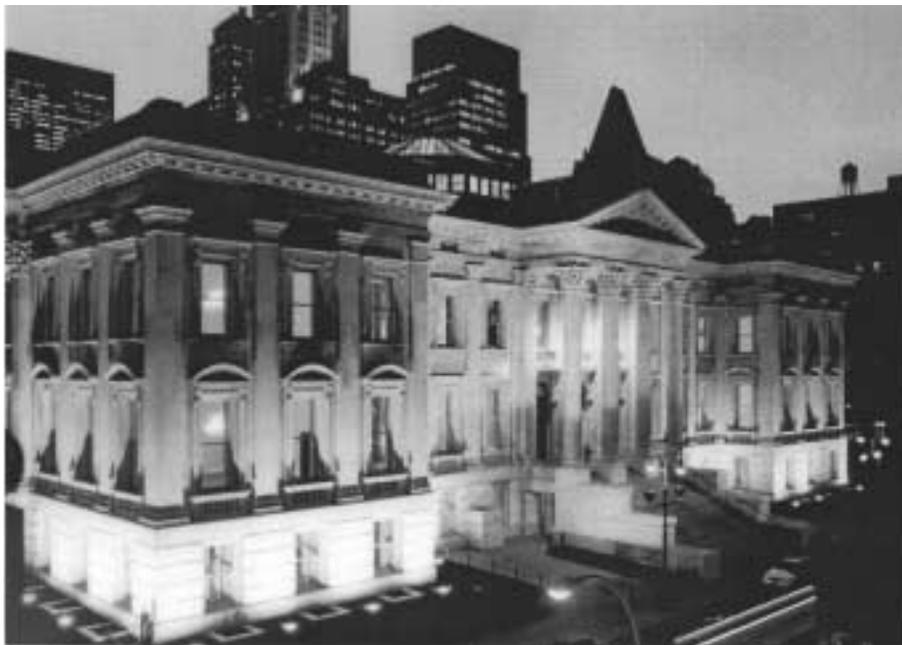
Fig. 1. Tweed Courthouse, 52 Chambers Street, New York City, restored exterior. The exterior of the courthouse, constructed of Tuckahoe and Sheffield marbles, was completely restored. More than 1,500 pieces of stone were repaired across the entire building facade. The entire 1,220-foot-long cornice, including 335 modillions, was replaced. The monumental Chambers Street stairway, which was removed in the 1940s for street widening, was rebuilt as the main entrance to the building. Along with the re-establishment of the three double-doorway entrances on the main floor, the restored stairway provides code-complying egress for the new uses of the building. Previously, the building did not have adequate egress and exiting. Photograph by Michael Rogol.

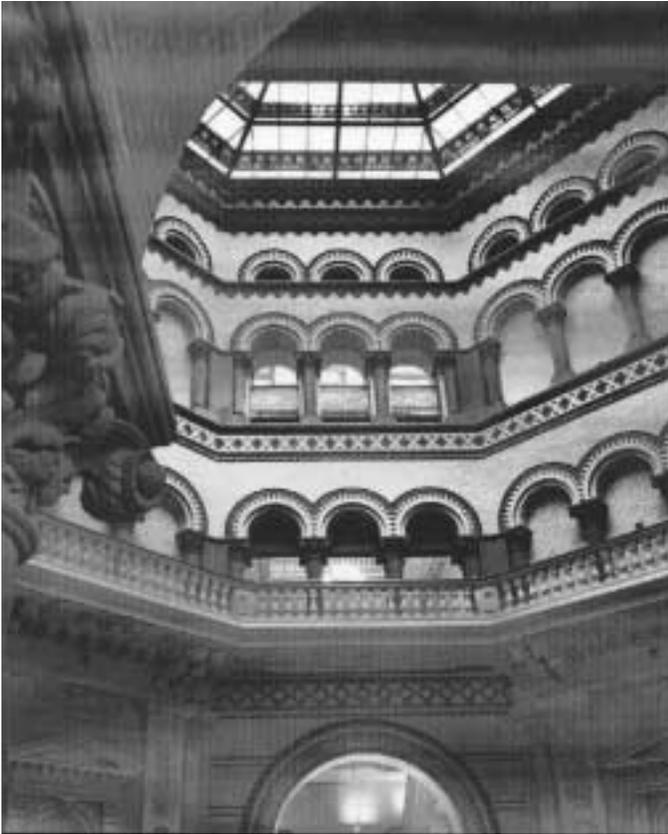
Fig. 3. Restored rotunda. The key to the fire-management plan was the restoration of the rotunda for use as a smoke reservoir. In the event of fire, smoke and combustion gases are collected in the upper section of the rotunda, above and below the stained-glass laylight. The arched openings at the upper level were filled in with heat-resistant glass panels. Fans at the attic level extract smoke directly to the exterior, making the connecting corridors and staircases safe egress routes. Photograph by Michael Rogol.

Instead, the approach that was taken during the restoration of the building treated the large central space of the rotunda as an advantage, rather than a disadvantage, in managing the effects of a fire (Fig. 3). The volume of space above and below the decorative laylight in the upper portion of the rotunda, just under the skylight, would act as a smoke reservoir, collecting and exhausting smoke and combustion gases from the space. Central to the success of the rotunda as a smoke reservoir was the installation of four large fans at the attic level, which would extract smoke from the top of the rotunda. These fans are visible only from within the attic and not from any level of the rotunda or from the occupied floors. The fans

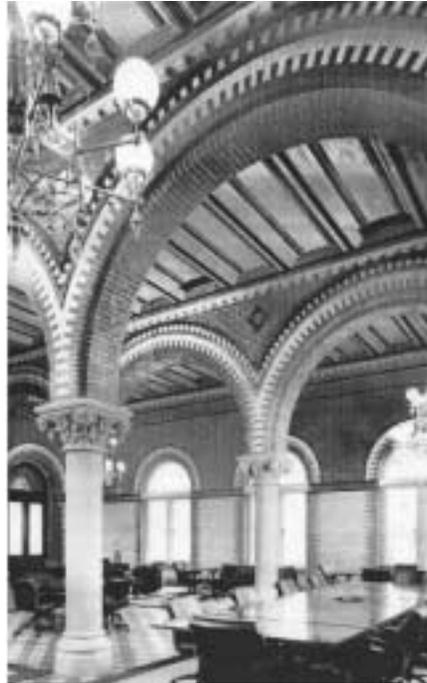
Fig. 5. Restored courtroom in the south wing. This courtroom, designed by Leopold Eidlitz, has tile floors and polychromed-brick jack-vault ceilings. The bottom flanges of the rolled-iron beams supporting the jack vaults are exposed. The reproduction chandeliers provide the principal illumination for the room, using frosted tungsten halogen lamps. The historic fixtures also serve as emergency lighting throughout most of the building; they are wired to emergency circuits that are activated by the fire- and smoke-detection system. This arrangement alleviates the need for modern emergency-lighting fixtures, which would be visually intrusive in the historic spaces. Because the detector heads for the air-sampling smoke-detection system are incorporated into the lighting fixtures, they are not visible in the room. Photograph by Lily Wang.
