Previous pages: One of the two limestone basreliefs carved by Maxfield Keck on either side of Union Terminal's main entry. This page: The building's soaring rotunda measures 106 feet tall at its highest point.

In December of 2018, a comprehensive restoration of the 500,000-square-foot station, from the glass mosaic murals to the aluminum light fixtures, was completed. The scale of the project, which cost \$228 million and took a total of three years, was almost as ambitious as

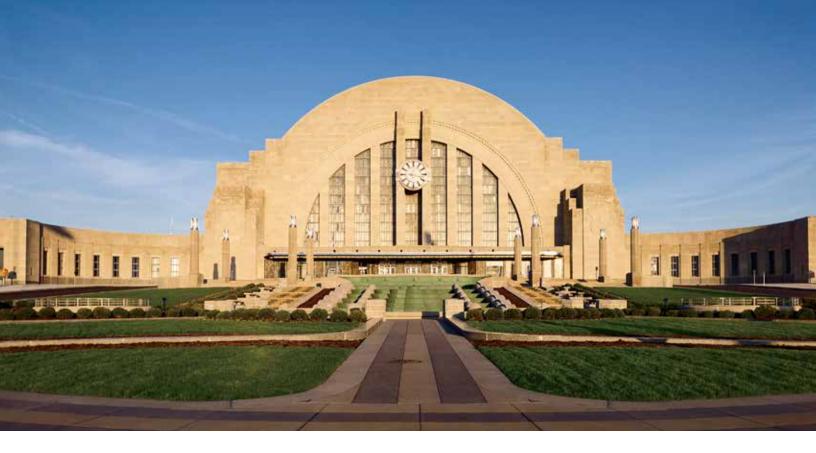
Artist Winold Reiss chose durable glass tiles as the medium for the original mosaic murals at Union Terminal. Bands of colored terrazzo underfoot echo the pattern of the ceiling's golden rings.

In the rotunda, EverGreene's conservators climbed scaffolding to reach Reiss' two panoramic mosaic murals, which cover 4,200 square feet. Across them parade riverboat captains, dockworkers, pioneers, and Native Americans, all rendered in brilliantly colored glass tiles. EverGreene found that, structurally, the mosaics had held up well. Team members cleaned them, filled cracks by injecting a stabilizing compound, and then cleaned the mosaics again. Missing tiles were replaced with close matches from Orsoni, a Venetian company.
